FINAL FEASIBILITY STUDY REPORT

Bucks Bar Road Bridge at North Fork Cosumnes River

Bridge No. 25C-0003

El Dorado County, California

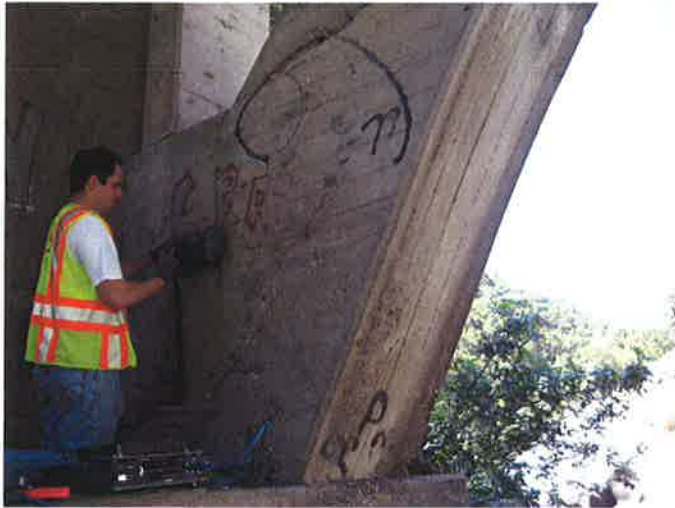
Testing to identify the reinforcement spacing, depth and existence and concrete strength of the existing bridge was performed on July 1, 2009. Several locations of the existing bridge were scanned to establish the existence, depth and spacing of the reinforcement. Locations scanned included the deck, arch ribs, spandrels, abutment stems and two retaining wall faces. A report of scan results is included in the Existing Bridge Condition Assessment, Attachment A.

Scanning detected no top reinforcement in the deck slab and confirmed the abutments are unreinforced concrete greater than 18 inches thick. In addition, bars not shown on the as-builts were identified on the interior face of the arch rib extending past the connection to the thrust block. No rebar was found in any of the south abutment walls up to the effective scanning depth of the equipment (18 inches).

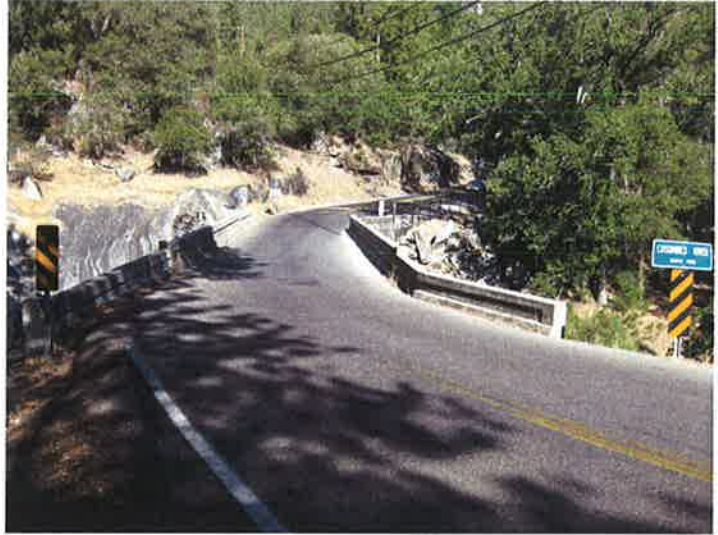
The design speed for the horizontal alignment is 20 mph based upon the radius and superelevation of the existing roadway. The radii of the two curves entering and exiting the bridge are both approximately 150 ft, with the bridge being on a tangent.

The existing bridge cross section is flat, without a normal crown section. Through multiple sight visits, most drivers “round” the tangent portion of the bridge in order to maintain speed.
