PRELIMINARY
GEOTECHNICAL ENGINEERING STUDY
for
DIAMOND SPRINGS PARKWAY
El Dorado County
Placerville, California

Project No. E07479.001
February 2008

Subject: **DIAMOND SPRINGS PARKWAY**
Placerville and Diamond Springs, El Dorado County, California
PRELIMINARY GEOTECHNICAL ENGINEERING STUDY

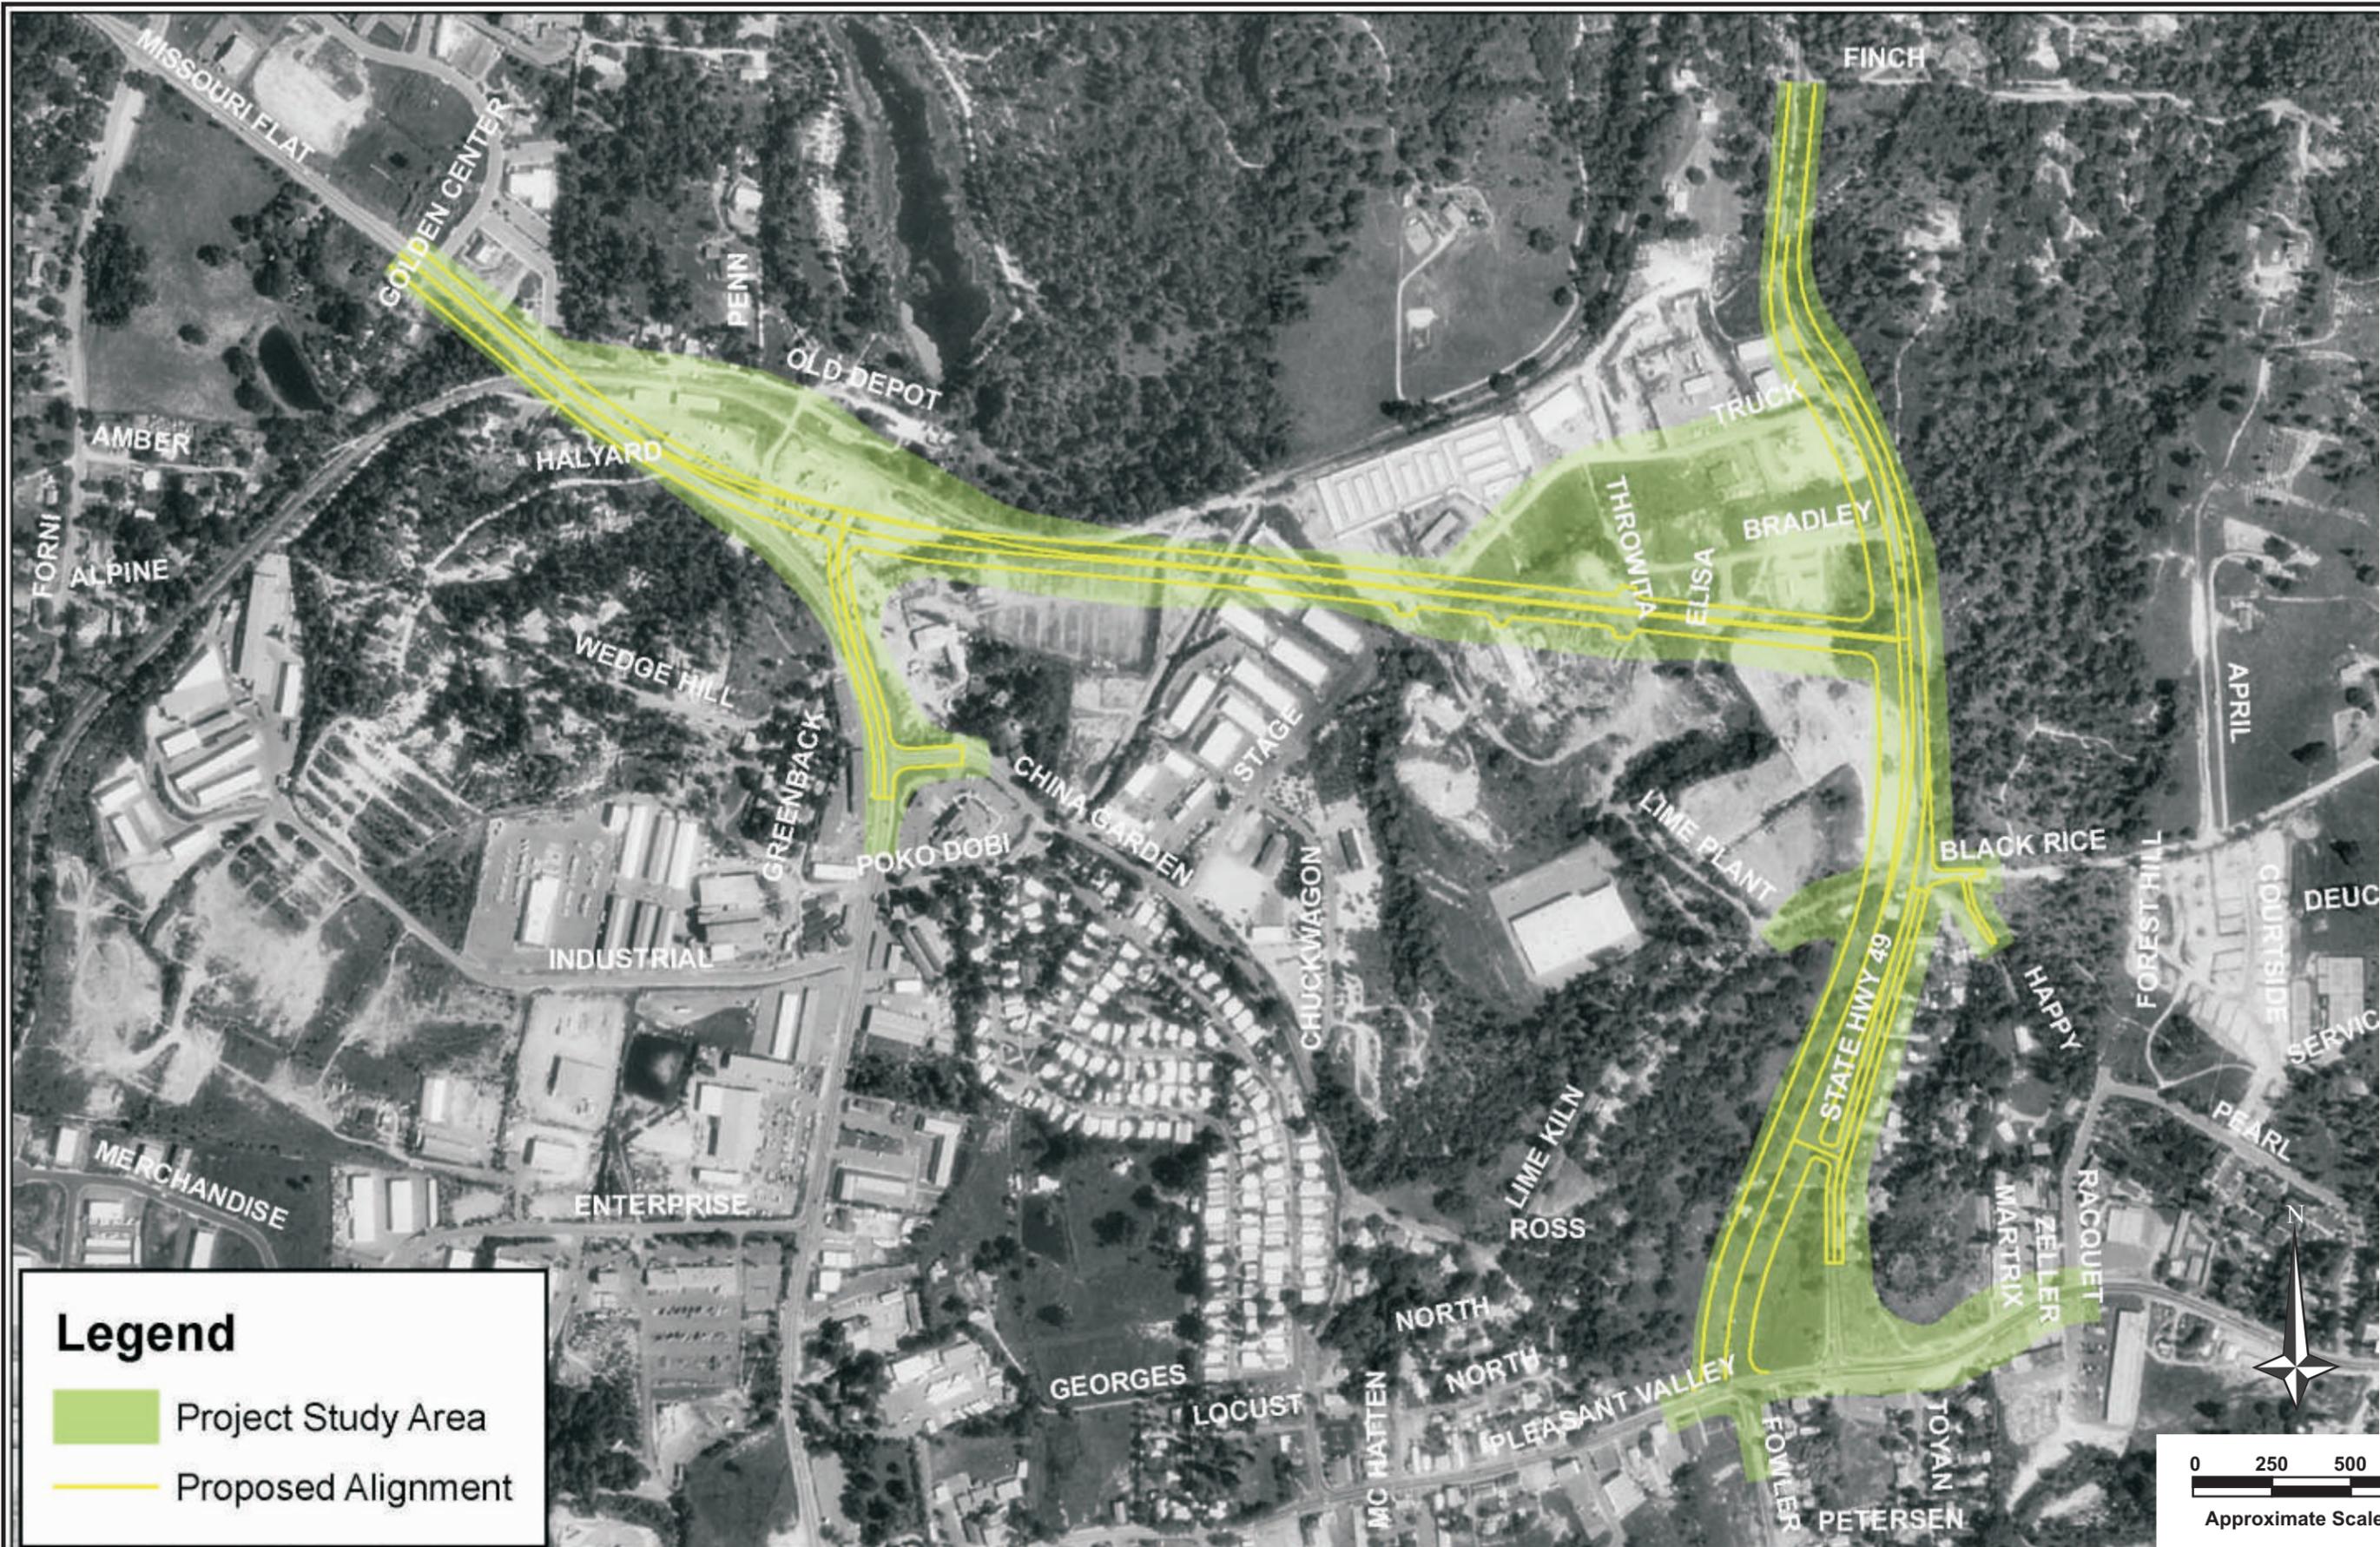
Vicinity Map
Site Plan

BASE MAP REFERENCE: Proposed Parkway Alignment, Exhibit 2, El Dorado County DOT, Michael Brandman Associates, Dated 2007
